**Flood Control Project Maintenance
Levee Inspections****LMA District Cover Sheet****Spring 2013 Levee Inspection Results****Reclamation District No. 0307 Lisbon**

Levee Inspection Report By Mile - Spring 2013

Reclamation District No. 0307 Lisbon

Waterway						Bank	Unit Miles	Inspection Start/End	Inspector	
Unit No. 01 Sacramento River						Right	6.65	03/07/2013 03/07/2013	Herman Phillips	
LMR No.	Levee Mile		Category	Item	* Location + Rating	Action/Comment	GPS Latitude/Longitude		Issue No.	
	Start	End					Start	End	Photo	
1				Operations & Maintenance Manuals	WS Ma	A		° °	° °	18
DWR ID: DWR_RD0307_01_s_2013_18										
2				Emergency Supplies & Equipment	WS Ma	M		° °	° °	20
DWR ID: DWR_RD0307_01_s_2013_20										
3				Flood Preparedness & Training	WS Ma	M		° °	° °	21
DWR ID: DWR_RD0307_01_s_2013_21										
4	0.00	0.00		Vegetation	WS Ma	M	V1 : Control annual grass and weeds on the levee slopes and easements.	38.480090 ° -121.549508 °	38.480090 ° -121.549080 °	13 Y
DWR ID: DWR_RD0307_01_s_2013_13										
5	0.00	0.00		Vegetation	LS Ma	A	V1 : Control annual grass and weeds on the levee slopes and easements. Inspector Comments: The District has contracted with a spray contrac

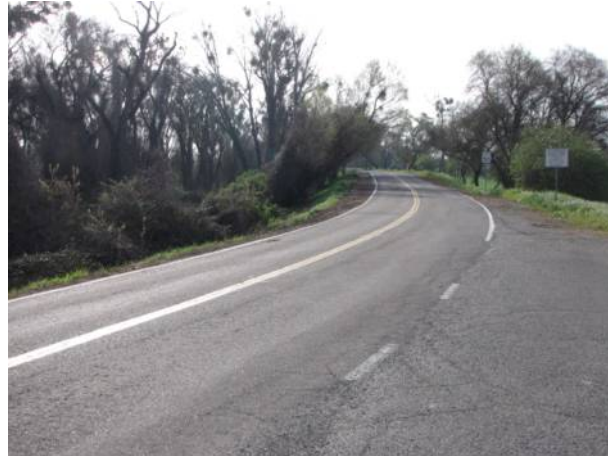
Levee Mile Report Line	4
Start Levee Mile	0.00
End Levee Mile	0.00
Location	Water Side
Category	
Item	Vegetation

Looking downstream from levee mile 0.00 at the waterside of the levee section. Photo taken 3-14-2013

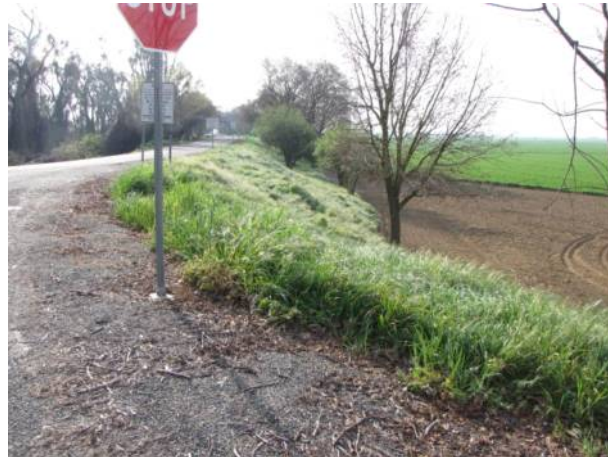
Levee Mile Report Line	5
Start Levee Mile	0.00
End Levee Mile	0.00
Location	Land Side
Category	
Item	Vegetation

Standing at levee mile 0.00 landside levee slope looking downstream of RD 307. Photo taken 3-14-2013.

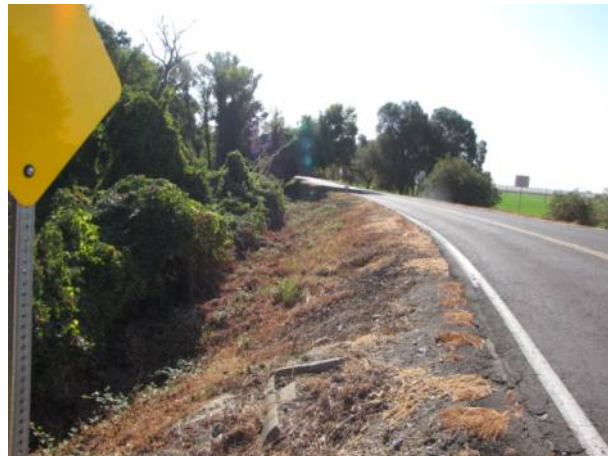
Levee Mile Report Line	6
Start Levee Mile	0.00
End Levee Mile	0.00
Location	Water Side
Category	
Item	Vegetation

RD 307 looking downstream from levee mile 0.00 waterside slope. Photo taken 10-18-2012.

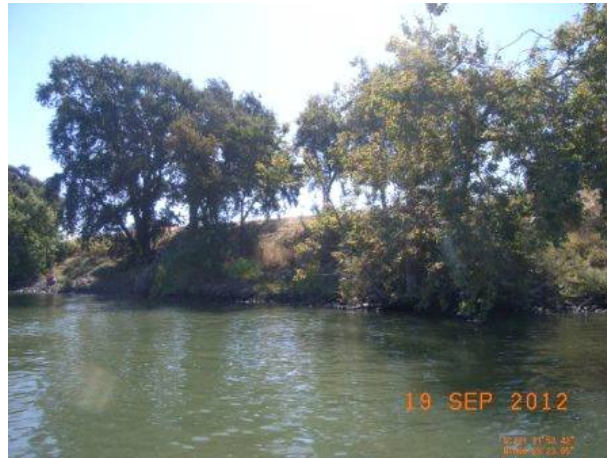
Levee Mile Report Line	14
Start Levee Mile	1.20
End Levee Mile	1.31
Location	Water Side
Category	Supplemental
Item	USACE Erosion Survey

USACE 2012 Photo #1

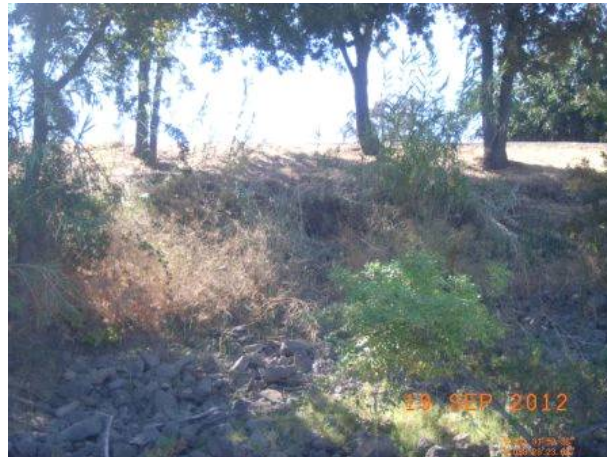
Levee Mile Report Line	14
Start Levee Mile	1.20
End Levee Mile	1.31
Location	Water Side
Category	Supplemental
Item	USACE Erosion Survey

USACE 2012 Photo #2

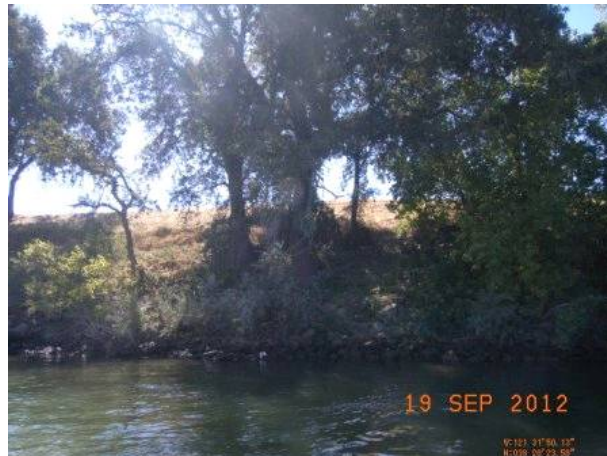
Levee Mile Report Line	14
Start Levee Mile	1.20
End Levee Mile	1.31
Location	Water Side
Category	Supplemental
Item	USACE Erosion Survey

USACE 2012 Photo #3

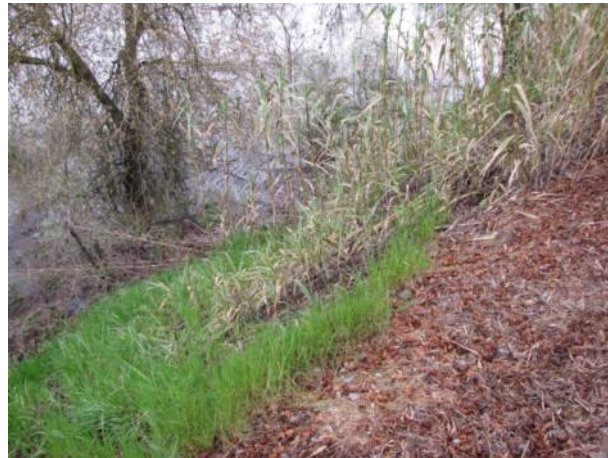
Levee Mile Report Line	19
Start Levee Mile	2.43
End Levee Mile	2.45
Location	Water Side
Category	
Item	Erosion / Bank Caving

Looking downstream from waterside levee mile 2.43 at erosion on bank, you can't see the erosion very good because of the overgrowth of bamboo. Photo taken 3-18-2011. This site was discovered by the land owner Mr. Borges.

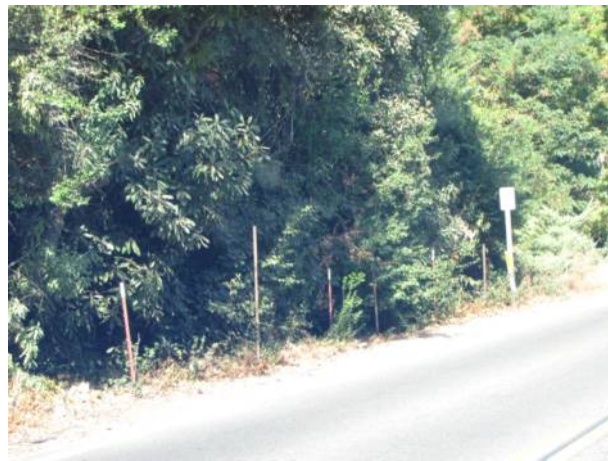
Levee Mile Report Line	26
Start Levee Mile	3.71
End Levee Mile	3.75
Location	Land Side
Category	
Item	Vegetation

Unsatisfactory growth of vegetation blocking the view of the levee section. Photo taken 10-18-2012.

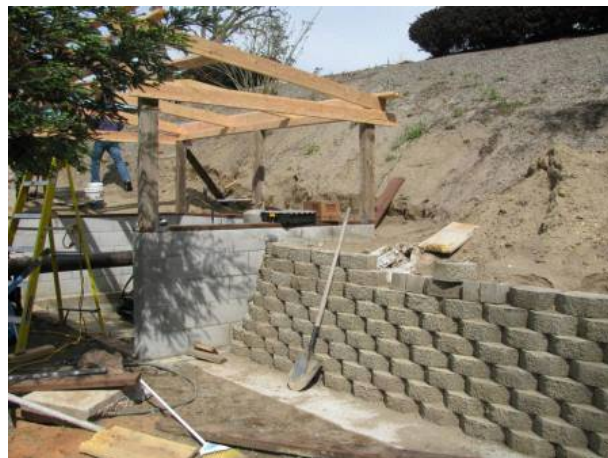
Levee Mile Report Line	33
Start Levee Mile	4.36
End Levee Mile	4.36
Location	Land Side
Category	
Item	Encroachments

RD 307 Levee mile 4.37 Retaining wall in the levee toe. Photo taken 2013.

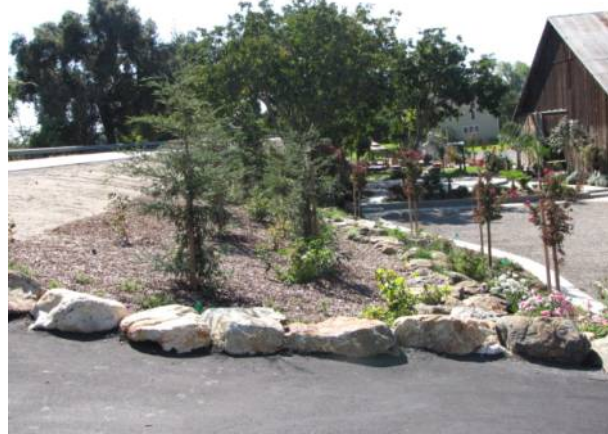
Levee Mile Report Line	37
Start Levee Mile	4.64
End Levee Mile	4.68
Location	Land Side
Category	
Item	Encroachments

At this location, levee mile 4.64 thru 4.68, some of the unauthorized trees and landscaping as well as a sprinkler system on the slope and toe of the levee section. This photo was taken 3-2012.

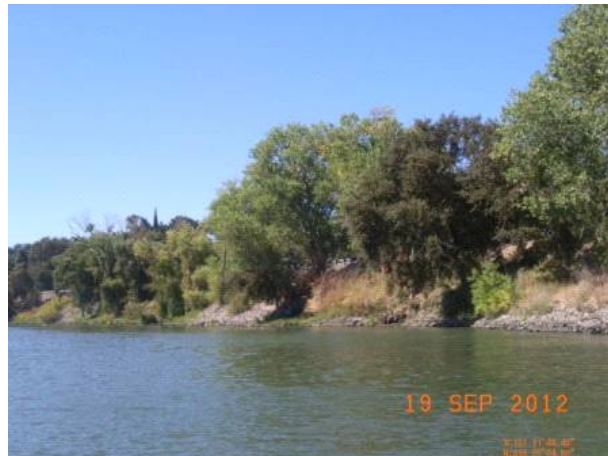
Levee Mile Report Line	45
Start Levee Mile	6.19
End Levee Mile	6.39
Location	Water Side
Category	Supplemental
Item	USACE Erosion Survey

USACE 2012 Photo #1

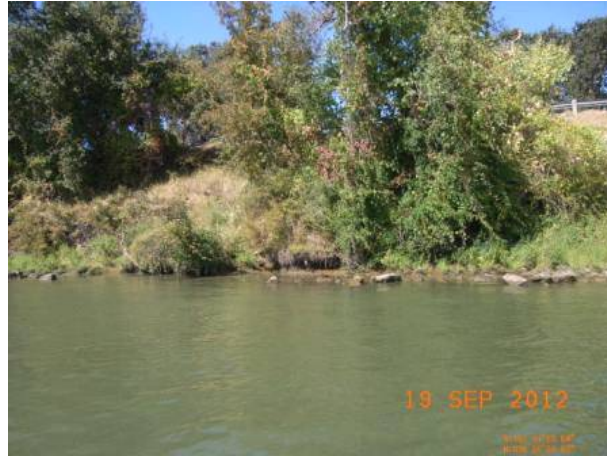
Levee Mile Report Line	45
Start Levee Mile	6.19
End Levee Mile	6.39
Location	Water Side
Category	Supplemental
Item	USACE Erosion Survey

USACE 2012 Photo #2

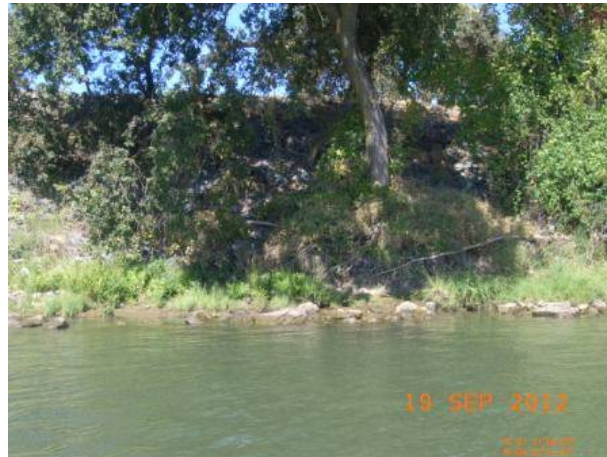
Levee Mile Report Line	45
Start Levee Mile	6.19
End Levee Mile	6.39
Location	Water Side
Category	Supplemental
Item	USACE Erosion Survey

USACE 2012 Photo #3

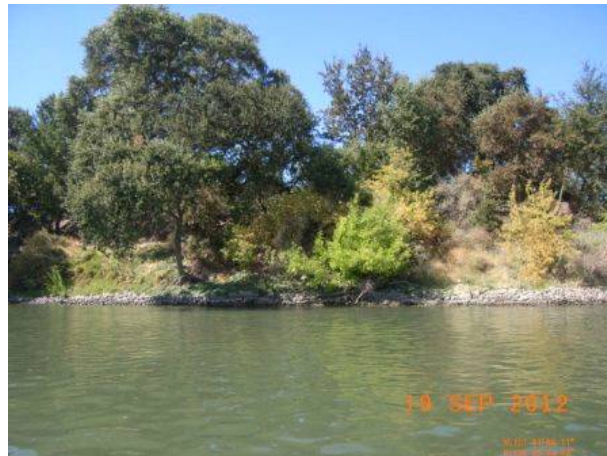
Levee Mile Report Line	46
Start Levee Mile	6.43
End Levee Mile	6.56
Location	Water Side
Category	Supplemental
Item	USACE Erosion Survey

DWR ID: DWR_RD0307_01_s_2013_7		
46	6.43	6.56	Supplemental	USACE Erosion Survey	WS	M Ma	Inspector Comments: 2011 - Erosion pockets likely from tree popouts. This site has been in the inventory before and been fixed with emergency bank rock but continues to fail. 2012: No observed change. [2012 Site ID: SAC_43-1_R]	38.431726 ° -121.533200 °	38.429957 ° -121.533035 °	62 Y
								DWR ID: DWR_RD0307_01_s_2013_62

USACE 2012 Photo #1

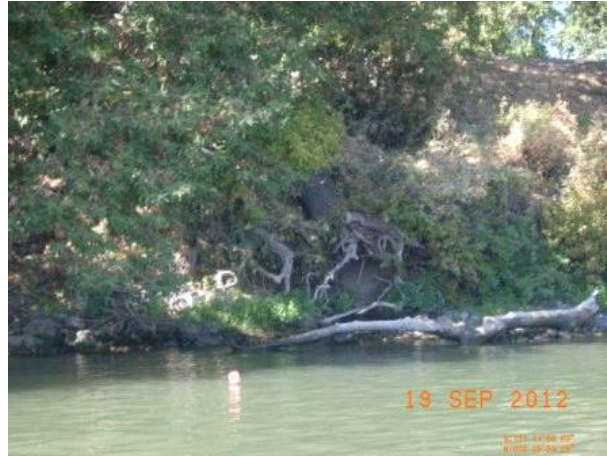
Levee Mile Report Line	46
Start Levee Mile	6.43
End Levee Mile	6.56
Location	Water Side
Category	Supplemental
Item	USACE Erosion Survey

USACE 2012 Photo #2

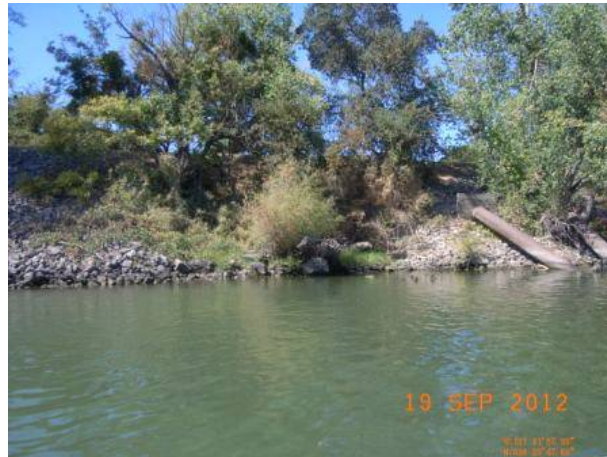
Levee Mile Report Line	46
Start Levee Mile	6.43
End Levee Mile	6.56
Location	Water Side
Category	Supplemental
Item	USACE Erosion Survey

USACE 2012 Photo #3
